Manhole Inspection Summary

Manhole # S67Q__004MH

Insp Date: **5/14/08 2:16 PM**

Location Address: **1501 Charlotte Ave.**

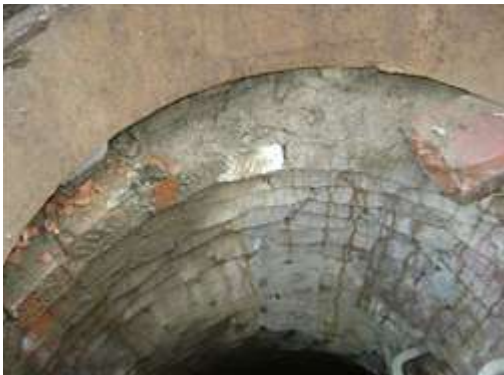
Defect 1

Condition: ☐ Sound ☐ Cracked ☐ Root Intrusion ☒ Loose Brick ☒ Deteriorated

Infiltration: ☐ None ☒ Joint ☐ Cracks ☒ Mortar ☐ Roots ☐ Wall

Missing bricks and loose mortar under frame.

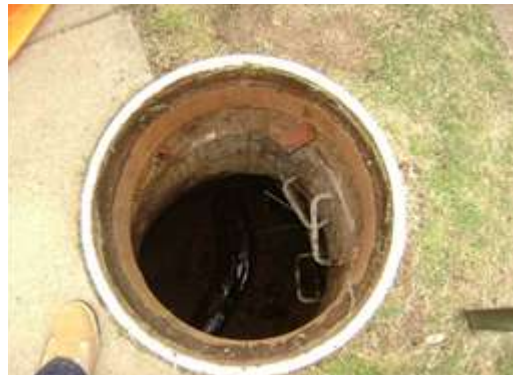
Defect 2

Offset: **3** (in.)

Frame offset defect

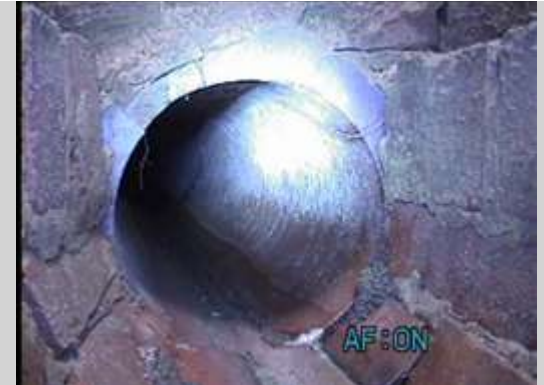
12 O'Clock Outflow

8 in. Circular Gravity Sewer
Pipe Out @ 12 O'Clock

Infiltration: **None** Pipe Seal Cond: **Sound**

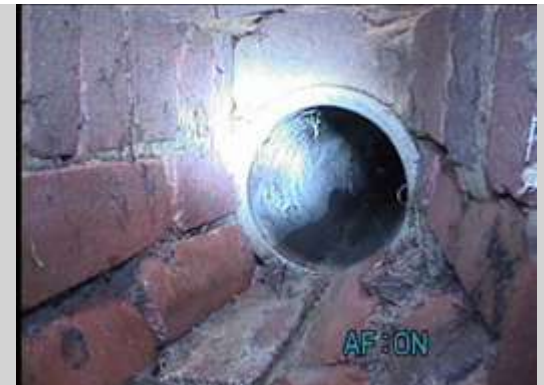
6 O'Clock Inflow

6 in. Circular Gravity Sewer
Pipe In @ 6 O'Clock

Infiltration: **None** Pipe Seal Cond: **Sound**
